Final Project Report

STROUBLES CREEK STREAM RESTORATION

*A collaborative effort between the Virginia Department of Conservation and Recreation and
Virginia Tech Biological Systems Engineering Department*

13 August 2010

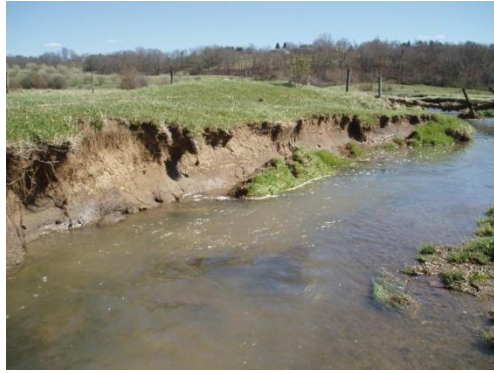
Figure 2. Streambank erosion along Stroubles Creek on the Heth farm.

bank retreat processes were taking place, many of which are caused by scour of the lower streambanks, which then lead to cantilever failure of the upper bank (Figure 2). The Bank Toe Erosion Model (BSTEM version 4.1) was used to better understand the factors that contributed to bank failure, and to test the effectiveness of restoration design. It is an Excel-based model that calculates bank factor of safety (FS) for new or existing banks (USDA-ARS, 2006). It can also be used to model hydraulic erosion caused by hydraulic shear stress. Thus, the effects of erosion protection on the bank and bank toe can be incorporated to show the effectiveness of such measures (USDA-ARS, 2006). The model was applied to riffle cross sections along the design reaches of Stroubles Creek to determine current bank stability and to estimate the potential effects of our restoration design.

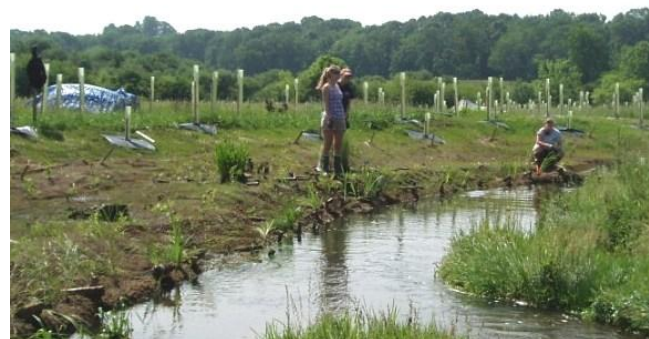
Figure 6. Students planting streambank with inset floodplain (research treatment 3). Students are standing on the inset bench.

The final design cross sections were ultimately determined based on all of the design methodologies and existing site constraints (Appendix C). To minimize impact to Stroubles Creek and because the stream sinuosity on the project site was similar to the reference reach, we did not change the existing planform and baseflow channel width. Thus, the main dimensions were elevation and width of the inset floodplain. Elevation of the inset floodplain was determined primarily based on the bed material entrainment constraints discussed previously (mobilize sand annually and do not mobilize the D84 material at the 2.5-yr return period); this elevation corresponded to existing depositional surfaces on the site, confirming our design. Thus, the width of the inset floodplain was the most flexible aspect of the design. This width was set at each cross section based on site constraints. Extensive emergent floodplain wetlands exist along both mainstem Stroubles and the UT. The wetland hydrology is controlled by surface and subsurface hillslope runoff, a restricting subsurface soil layer which perches water on the floodplain, and a small levee along the channel. To minimize impact to these wetlands, the width of the inset floodplain bench was limited to a width that would not completely remove the levee and drain the floodplain wetlands. Once graded, the streambanks in research treatment 3 were stabilized and planted in the same manner as the treatment 2 reach. Figure 6 shows an example of research treatment 3 as constructed.

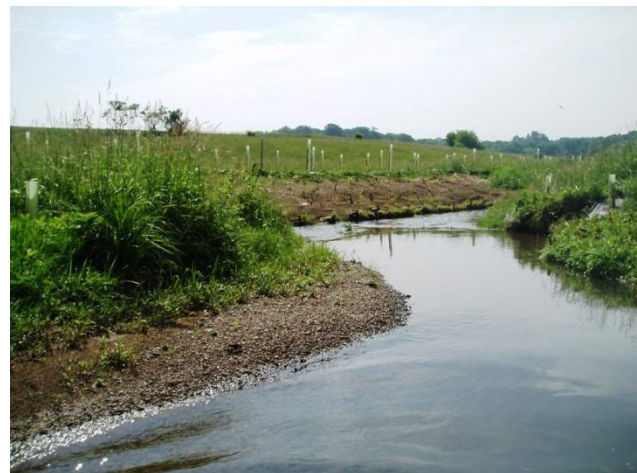
Figure 8. Alternating gravel bars forming at the restoration site.
